Tree Inventory, Assessment, and Protection Report

451 Santa Rosa Drive, Los Gatos Los Gatos, CA 95032

Town of Los Gatos

October 18, 2021

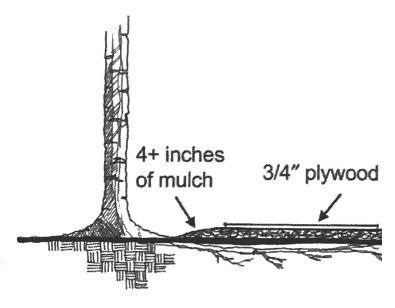
FIGURE 1: BRIDGING FOR ROOT PROTECTION

Tree protection has been provided in the L1.6 plan sheet. There is a combination of fence to provide exclusion from root zones and bridging with mulch and steel road plate at the ingress/egress between tree #743 and #744 (Figure 1). I provided recommended offsets for fence distances where possible in Appendix B. The L1.6 plan should also include this report along with the "Recommendations" section and Appendix B, D and E. Based on the site constraints and already impacted areas the L1.6 plan is adequate for fence locations and bridging measures.
